# **AN INVESTIGATION INTO THE EFFECTS OF FLOATING OBJECTS ON THE ELECTRICAL BREAKDOWN OF AIR INSULATION UNDER STEADY STATE HIGH VOLTAGE DIRECT CURRENT CONDITIONS**

A research report submitted to the Faculty of Engineering and the Built Environment, University of the Witwatersrand, Johannesburg, in part fulfilment of the requirements for the degree of Master of Science.

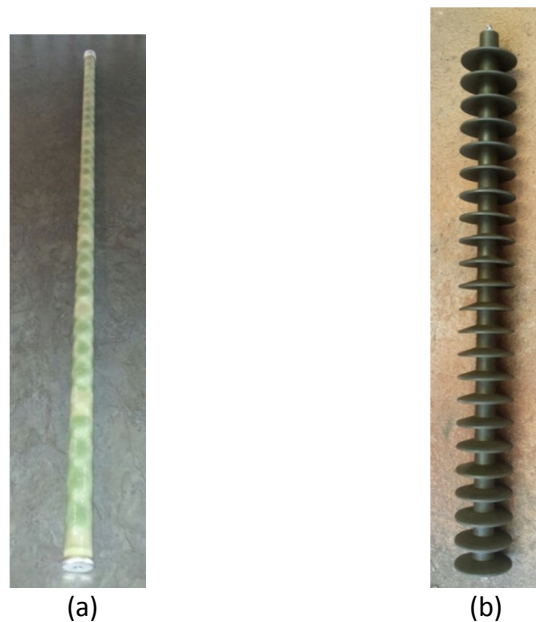
**Figure 11: (a) Uncovered original diode stack, (b) Diode covered with silicone rubber sheaths**

The tests were conducted outdoors. The individual diodes were encased in a fibreglass housing (Figure 11 (a)) and had a connecting length of 1 m.

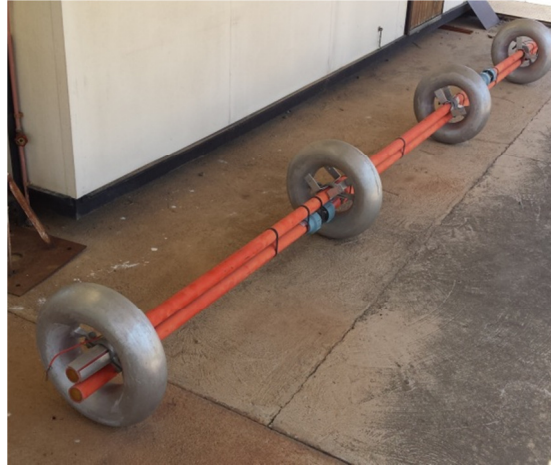
**Figure 12: Rectifier mounting platform**

possibility of tracking across the surface of the fibreglass. The diode stack was attached to a live-line pole for mechanical strength (Figure 12) and electric field grading rings were installed around the diode attachment points to manage the expected high fields in that area (Figure 13).

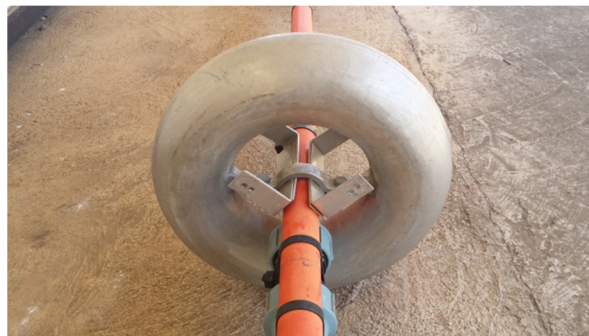
**Figure 13: Hardware rings used around connection points**

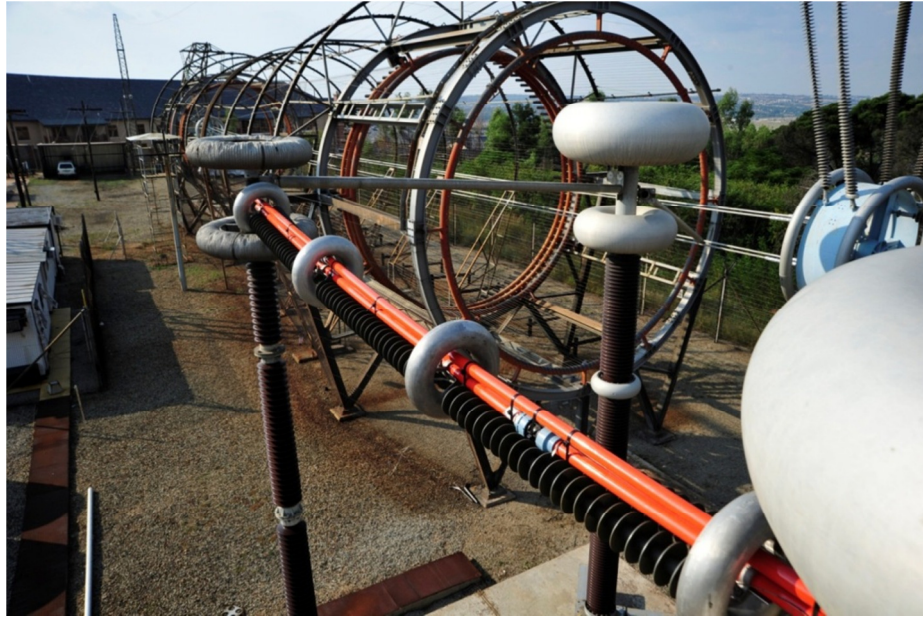
**Figure 14: Installation of the diode arrangement in the HV power supply circuit**

No specific technical design was done for the dimensioning of the grading rings, rather the implementation was based on the fact that these rings were available at the time of the construction. The diode arrangement was installed in the HV circuit as indicated in Figure 14.

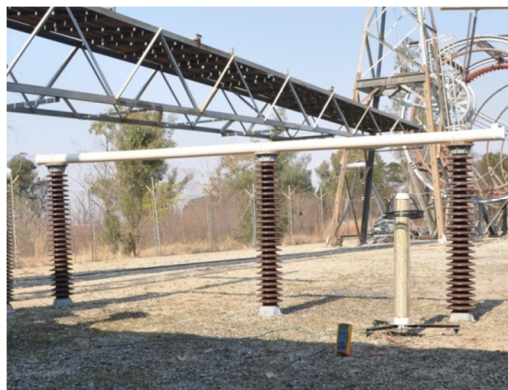
**Figure 15: Water resistor and voltage divider**

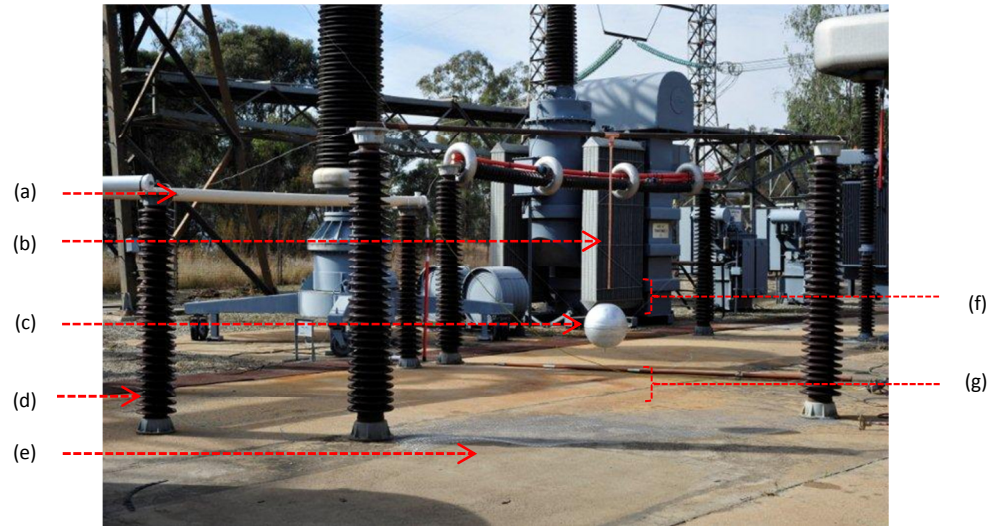
**Figure 21: Test setup for the floating sphere experiment**

- (a) Water resistor
- (b) Point electrode
- (c) Floating sphere
- (d) Porcelain stand-off insulators
- (e) Ground plane
- (f) Primary gap
- (g) Secondary gap

suppress the accumulation of free charge on the sphere [3]. The sphere was hollow and air-filled. Figure 21, shows the test setup for the floating metallic sphere tests, while Figure 22 presents a close-up view of the sphere itself.

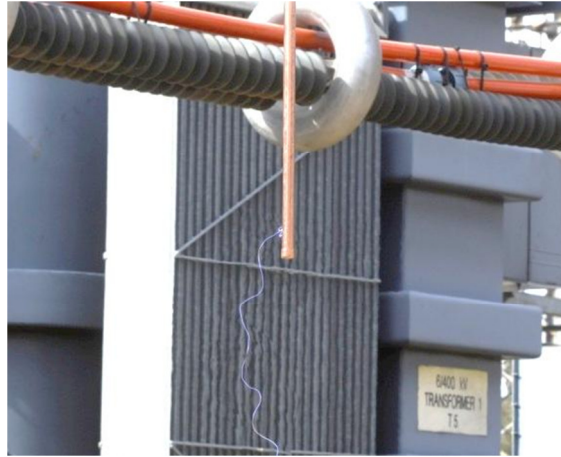
Figure 26: Picture showing arc initiation a short distance away from the tip of the point electrode

Figure 25 was recorded with a digital camera having a shutter speed of 0.12 ms. The image is therefore a pseudo-steady state representation of the discharge during the flashover.

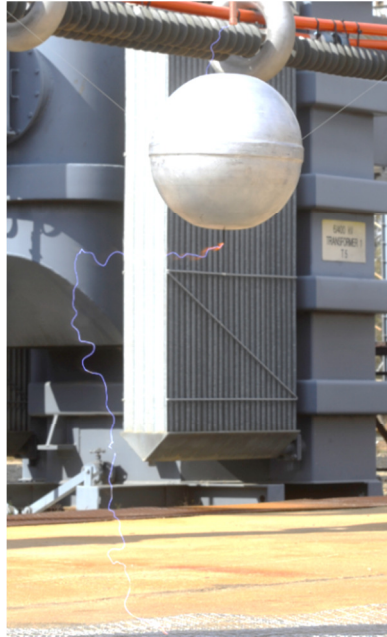
**Figure 35: Erratic arc path**

It was observed that the arc also did not necessarily follow the direct or shortest path between the electrodes. A tortuous arc path was observed as shown in Figure 35. Also evident is the flame like behaviour of the arc terminating on the protrusion at the bottom of the sphere.

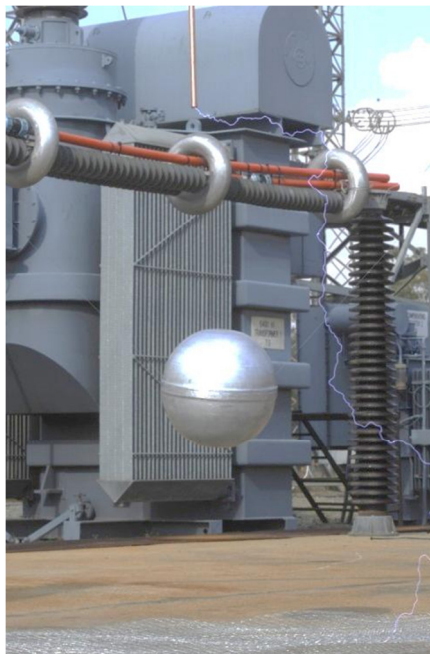
**Figure 36: Image showing the arc evading the sphere**

In two separate tests, it was observed that the arc ignored the floating object (Figure 36). The sphere was positioned in the centre of the gap. This result was not expected. For a total gap size of 1.4 m, a calculation using the linear equation shown in Figure 23, shows that a voltage of 692 kV would be required to break down the gap. The power supply was not capable of supplying this voltage. Practically, this situation could exist if the floating sphere became statically charged with an opposite polarity of the point electrode.

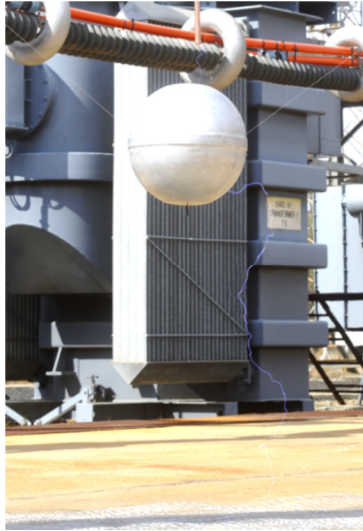
**Figure 40: Picture showing the arc origination at the bottom of the sphere  
and not the protrusion**

In certain cases it was observed that the arc did not terminate or originate from the tips of the electrodes, but rather along its length. For some tests, the arc was observed to originate from the sides of the sphere and not necessarily from the protrusion itself (Figure 40 and Figure 41).

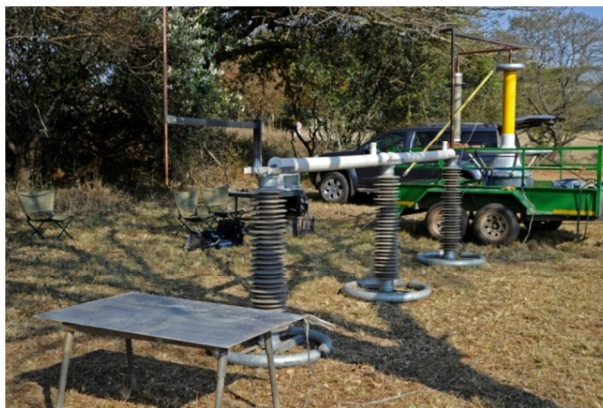
**Figure 1:** Rod-plane setup at 880 m above sea level (Pietermaritzburg). **Note:** the plane is elevated from ground-level
